San Juan Project Overhead Electric Line strike Investigation Summary

INCIDENT: Overhead Transmission Line Strike

LOCATION OF INCIDENT: Durango, Colorado between Hronich and Krajack well sites.

DATE OF INCIDENT: 3/31/09

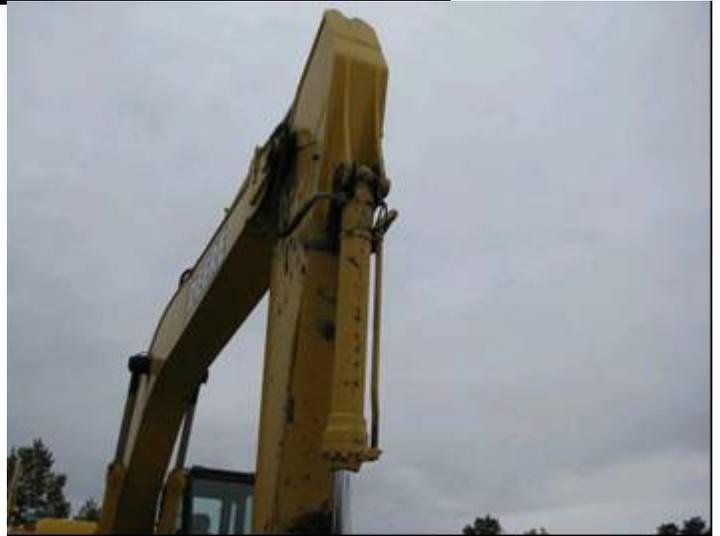
- 1.) Operator raised the trackhoe arm to a height that allowed contact with the overhead power line while transporting load
- 2.) Pre-fabrication of piping at the nearby site required movement of equipment under the power line to get to the installation site
- 3.) Failure to perform adequate risk assessment for moving pipe

- 2.5 Incorrect placement of equipment** – The trackhoe was raised to a height that allowed contact with the overhead power line.
- 3.1 Need for protective methods not recognized:** The individuals performing the work did not recognize that the overhead power line was in the travel path and proactive actions were needed.
- 4.1 Distracted by other concerns** – Trackhoe Operator was distracted by the load's proximity to a pick up truck and a gate, while near the power line. The Operator was also distracted by a funeral he was to attend the next day.

Trackhoe boom and contact point

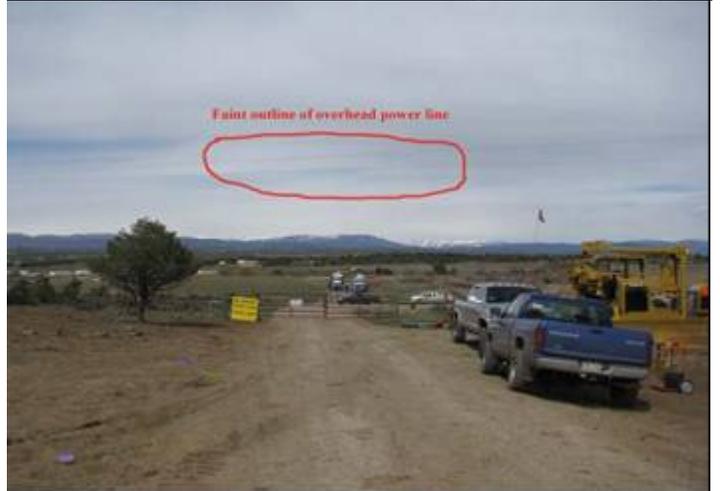
- 13.1 Antecedent not present** – No warning signs were present drawing attention to overhead power line.
- 13.3 Incorrect behaviour reinforced** – Inadequate site safety plans and JSEA's were reviewed and accepted on a regular basis by personnel responsible for safety oversight (both contractor and BP). Expectations around quality discussion for JSEA's, site safety plans and work plans were not reinforced by leadership (both contractor and BP).

Power line, gate and terrain of incident site.

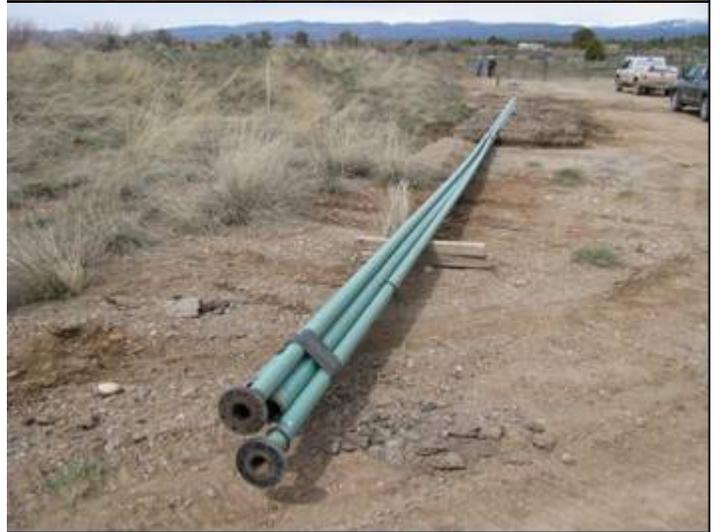
Bundle of 80 foot pipe sections
that were moved during the
incident
