# HAES 001/08

## Fall from height – Double MTI

## **HAES Safety Alert 001/08**

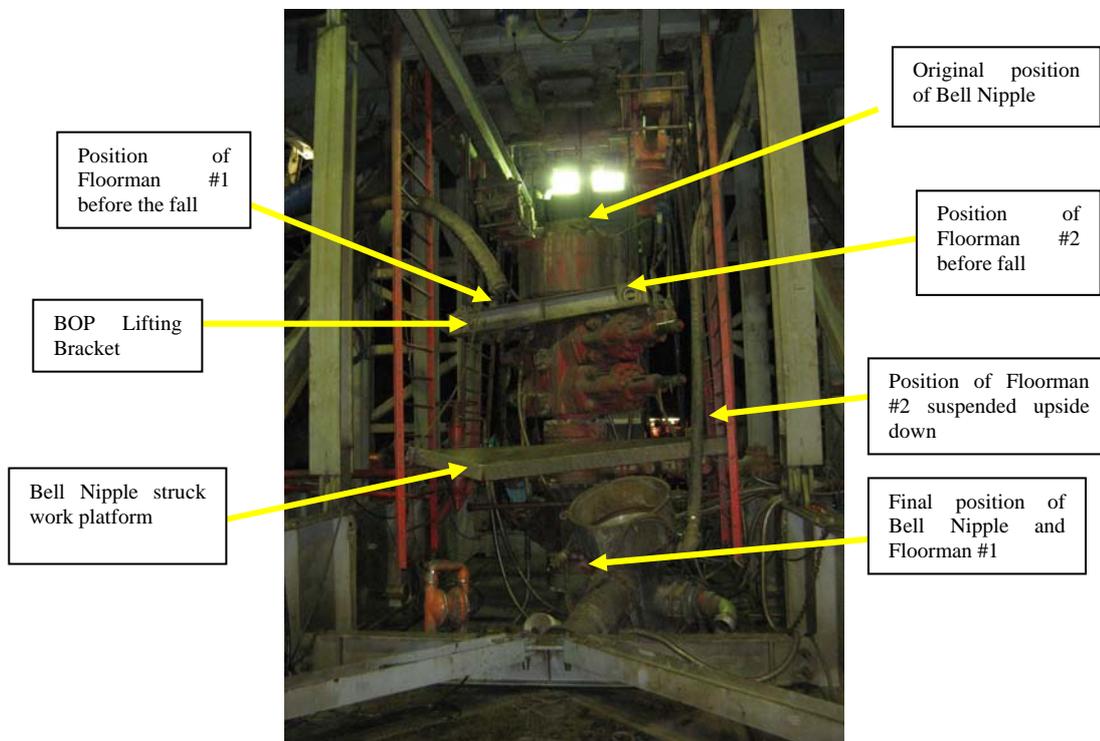
Two Floorman were working in the sub base approximately 4 metres above the ground removing the Bell Nipple from the top of the Blow out Preventer (BOP). The flow line had been disconnected from the Bell Nipple but was still attached to the winch on the drill floor when it was raised unexpectedly. The flow line flange knocked the Bell Nipple from the BOP seating and it fell to the ground. The Floorman had moved from one side of the Bell Nipple (v-door) to the other side (draw works) where they had just connected a soft sling to secure the Bell Nipple. One Floorman (#1 in picture below) had attached his shock absorbing lanyard to the Bell Nipple (approx 300 kg) and he was pulled down and fell to the ground. The other Floorman (#2 in picture below) was knocked off balance and fell backwards the extent of his shock absorber lanyard before coming to rest suspended upside down with the unused work platform stopping his fall any further. His lanyard did not extend far enough to activate the shock absorber. Both workers were standing on the BOP Lifting Bracket. Both workers received soft tissue injuries and returned to work the next day.

**This incident had the potential to result in a double fatality**

- The winch line connected to the flow line was supposed to have been disconnected.
- The original plan was to use two winch lines to remove the Bell Nipple. One through the mousehole and one through the rotary table. One line was ready but not connected in the mousehole. The Driller changed the plan to one winch. The winch operator said his was to use two winches.

- Neither worker was connected to the fall arrestors (Sala blocks). There are two on each side of the sub base fitted to the underneath of the rig floor.

- Lanyards used were not secured above head height and in one case was connected to an insecure anchor point (Bell Nipple).
- All four studs that attach the Bell Nipple to the BOP Annular had been removed before it had been secured.

- Procedure to be developed with sequential steps particularly the restraining of all equipment before unbolting or removing it.
- Ensure all provided safety devices are used (in this case fall arrestors)
- Processes to be put in place to ensure adequate and thorough Pre Job meetings are planned as part of the job, including the communication of hazards and why controls are necessary to prevent an accident.
- Ensure all instructions given during a job are specific, understood and recorded.
- Outline Supervisor expectations to ensure that jobs are undertaken safely
- Reinforce to the work force that they are empowered to STOP THE JOB when safety controls or precautions are bypassed.
- Ensure fall protection is secured to a suitable (stable) and approved above head height anchor point.
