# HIPO Lessons Learned Investigation Summary

**INCIDENT:** Oil Pipeline Tubing Failure

**BUSINESS UNIT:** GOM Deepwater – Atlantis PU

**LOCATION OF INCIDENT:** Atlantis – GC Block 787

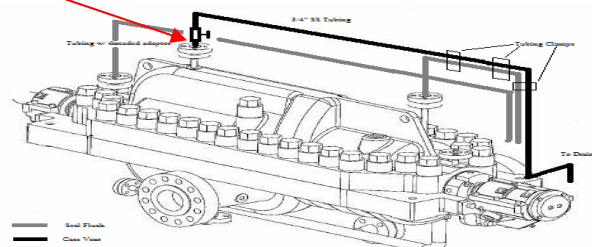
The Atlantis Facility had an incident occur when the stainless steel tubing attached to the Oil Pipeline Pump case vent fractured and parted, resulting in the loss of containment of approximately 193 bbls of treated crude oil. Additionally, 2.6 gallons of oil were released to the Gulf of Mexico, creating an oil sheen approximately 1500 feet by 1200 feet. All of the oil, except the volume released to the GoM, was captured in secondary containment, or adhered to the equipment, decks and structure in the area of the pipeline pumps, and the deck above. The incident was contained when the operator manually shutdown and isolated pump. The tubing failed at a threaded fitting due to excessive vibration.

Tubing not installed per MOC; pressure rating of tubing valve was too low, use of threaded fitting not in accordance with piping specification and no MOC/Work pack issued to add new structural steel under PAX pumps.

The MOC called for field installation without specifying support for the tubing. It only indicated to support from existing supports. The valve was not directly attached to flange (inherently safer design to eliminate unnecessary fittings and piping).

**Location where casing vent tubing fractured and parted**

Design the permanent tubing vent lines to comply with applicable standards and incorporate learning’s from the incident. Replace threaded pipe fitting with flanged or welded.
