## SAFETY ALERT - #01- 2010

### WORKER CRUSHED WHILE UNLOADING HYDROVAC TRUCK

RELEASE DATE: JANUARY 26, 2010

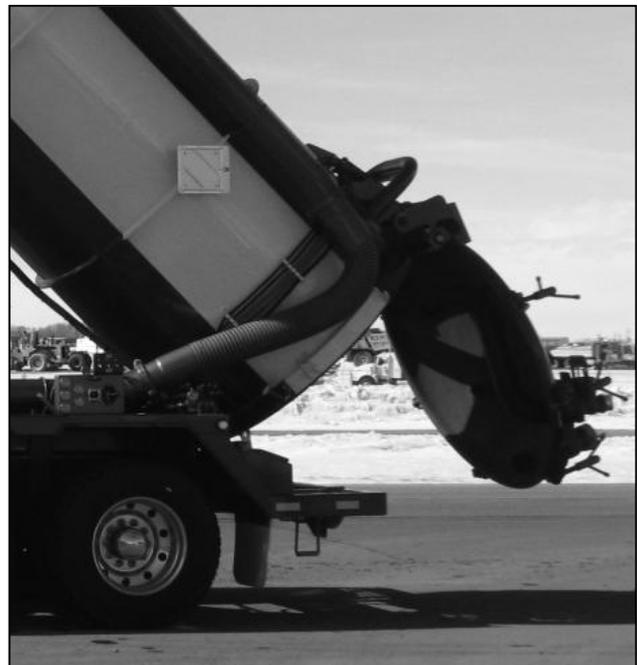
While dumping the contents of a hydrovac unit, a swamper was killed when he was caught in the closing hydrovac tank door.

- The workers had cleaned the tank and had both stepped down from the rear tank access platforms (also known as beavertails).
- The operator walked around to the driver's side of the truck to access the hydraulic control levers located directly behind the cab of the truck.
- Unknown to the truck operator, the swamper had climbed back up onto the right, rear beavertail and became caught in the swing radius of the rear tank door as it was closing.

Photograph of the rear door configuration of a typical hydrovac truck. Note crush point.

1. The bank of four control levers for the vacuum tank operation were changed;
  - Two control levers have been routed to other locations. The removal of these levers may allow for additional room between the remaining control levers to minimize an inadvertent activation due to their proximity; and
  - The control lever that operates the rear tank door was moved to the rear of the hydrovac tank, which allows the operator to maintain a clear line of sight of the door during opening and closing operations.

2. Flow restrictors have been installed on the hydraulic lines to the cylinder for the opening and closing of the rear tank door. This alteration slows down and controls the door's rate of travel;
3. Hydraulic controls have been tagged with permanent markings to provide clearer identification of the function of the control; and,
4. Signs warning of the hazardous pinch point have been installed on both sides of the rear of the vacuum tank.

1. An enhancement and ordering of the steps that will be followed for closing the tank door and lowering of the tank;
2. Added a requirement that the hydraulic rear door operator visually identifies any workers for whom the closing tank door may be a hazard, before the operator activates the controls; and
3. Added a provision for the engagement of the tank safety bar when the tank door is open. This provision would include a requirement that, when the tank is clean, the swamper should remove the bar while remaining in the operator's line of sight and then **instruct the truck operator** to close the door.
